## MEMORANDUM

**RE:** **Intersection Evaluation**  
Parmenter Road/Pine Hill Road Intersection  
Southborough, Massachusetts

MDM Transportation Consultants, Inc. (MDM) has prepared a safety and operations evaluation for the intersection of Parmenter Road and Pine Hill Road in Southborough, Massachusetts. The study location relative to area roadways is shown in **Figure 1**. This evaluation summarizes baseline traffic and safety conditions at the intersection including survey of daily and peak hour traffic volumes, travel speed data, intersection sight lines, and crash data. The purpose of the study will be to identify potential roadway and intersection improvements that are necessary to address existing traffic operations and safety.

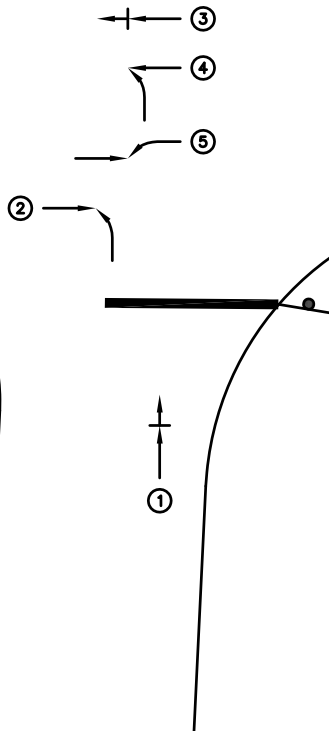
Figure 3

MDM had also obtained crash record data for the Parmenter Road at Pine Hill Road intersection for the period 2011 through August 2015 from the Southborough Police Department to develop a collision diagram to facilitate an understanding of potential causal factors for crashes. The collision diagram for the study intersection is shown in **Figure 3**.

In summary, Parmenter Road at Pine Hill Road experienced a crash rate slightly above the District-wide average, therefore safety countermeasures may be warranted at or near the intersection. A review of the MassDOT crash data indicates and roadway characteristics indicate that roadside obstructions, lack of clear zones, and limited sight distance are likely contributing factors in the reported crashes. A discussion of potential countermeasures is presented under Recommendations.

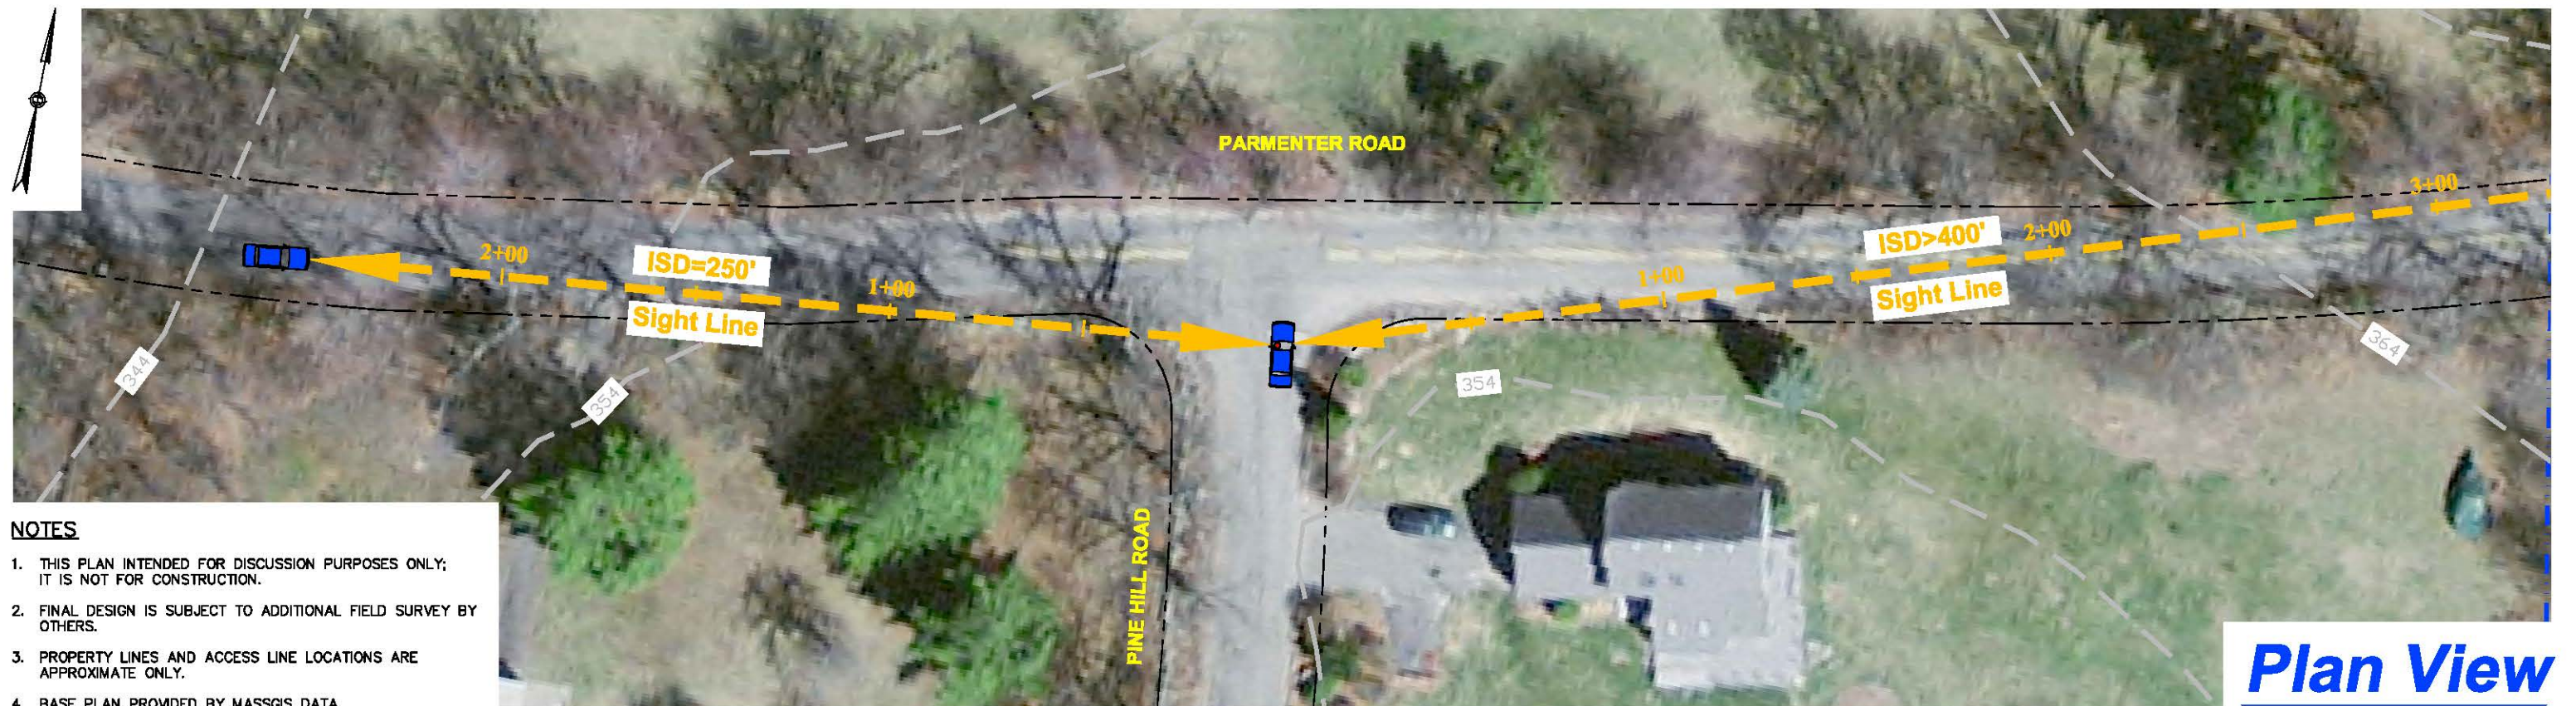
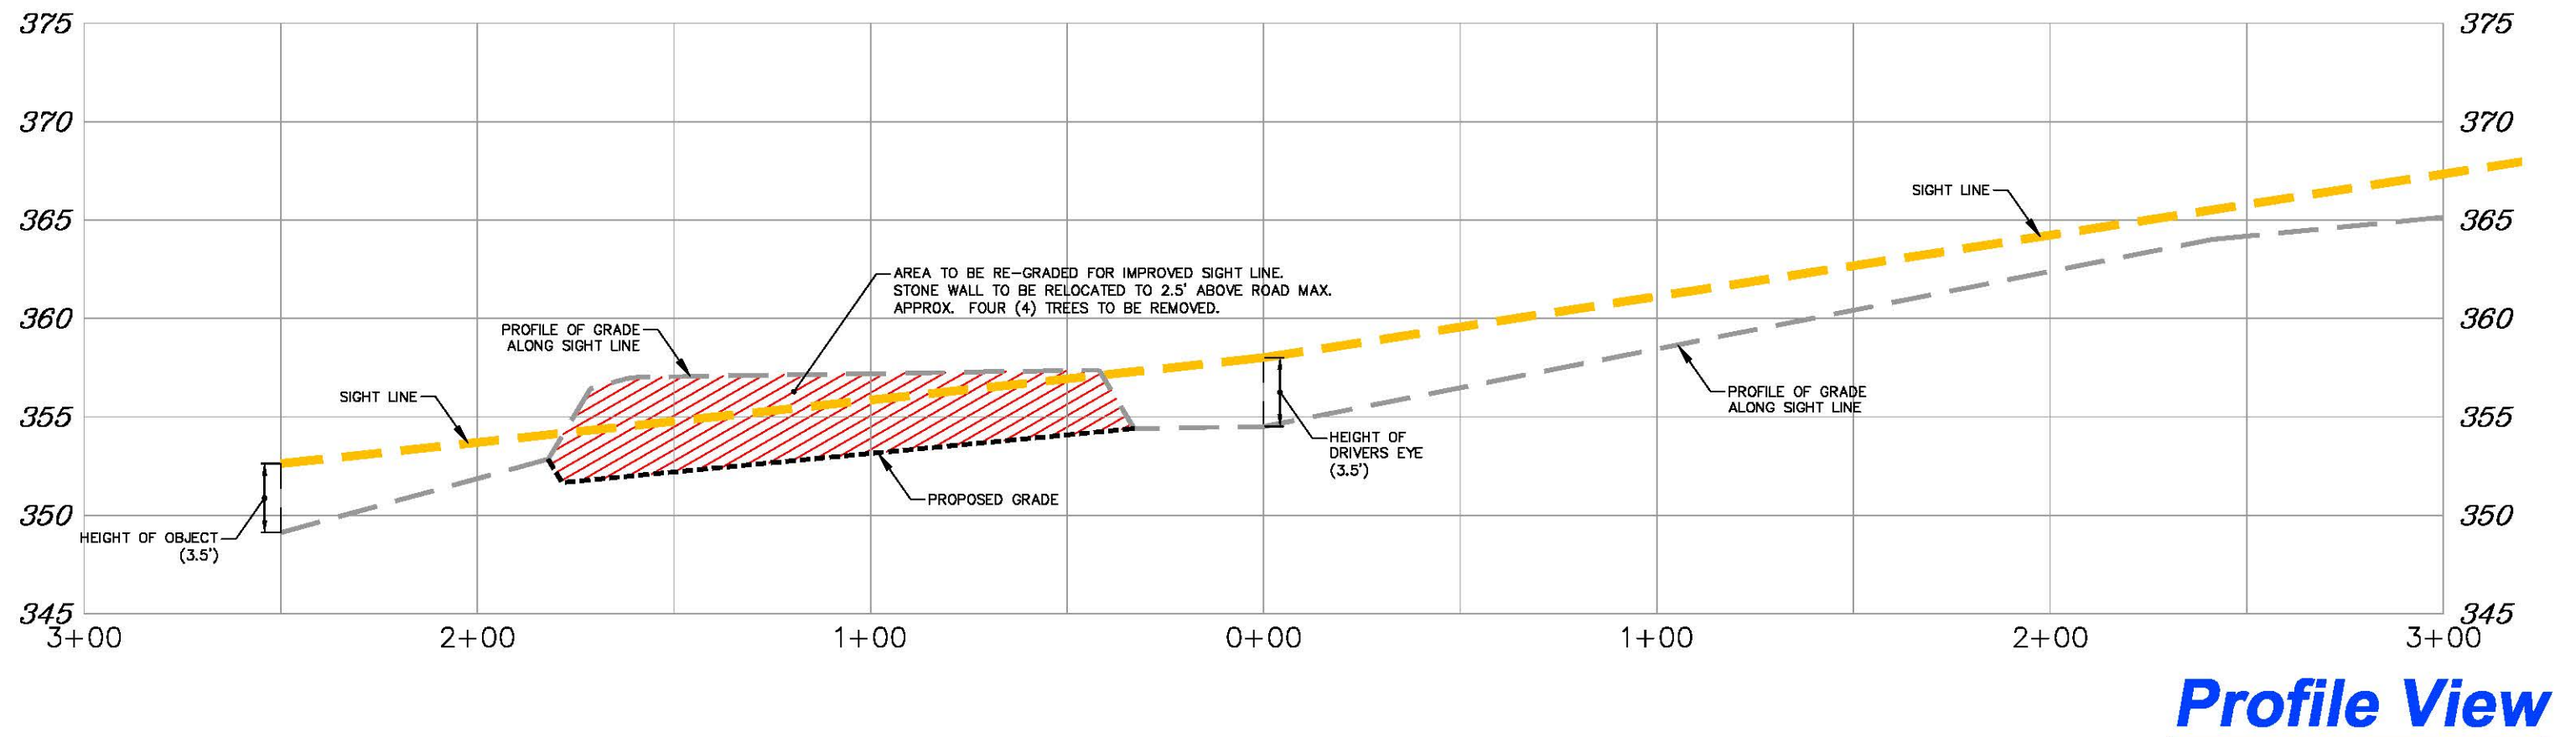
**Figure 4**  
*Intersection Sight Distance*

The results of the ISD analysis presented in **Table 5** indicate that the available sight line looking east from Pine Hill Road onto Parmenter Road exceed both the minimum and ideal sight line recommendations from AASHTO based on the regulatory speed and 85<sup>th</sup> percentile speed. The available sight line looking to the west from Pine Hill Road onto Parmenter Road currently do not satisfy even the minimum recommended sight line requirement for the regulatory speed limit due to existing roadside obstructions in close proximity to the travel way including trees, stone walls, and the existing ground embankment.

A review of the existing features within the sight line looking to the west from Pine Hill Road onto Parmenter Road indicates that to maximize the available sight line the area should be re-graded within the sight line triangle, the stone wall should be removed and reset to a maximum height of 2.5 feet above the adjacent roadway grade and approximately four (4) trees should be removed. With said improvements the sight line looking to the west from Pine Hill Road onto Parmenter Road can be maximized to approximately 250 feet, as shown in **Figure 4**, which correlates to a design speed of approximately 25 mph.

- Intersection sight distance (ISD) looking west from Pine Hill Road onto Parmenter Road is severely limited to only 50± feet by an embankment, stone wall, vegetation, and several large trees.

MDM recommends that in the future the sight lines should continue to be maintained and that any new plantings (shrubs, bushes) or physical landscape features to be located within the driveway sight lines should also be maintained at a height of 2.5 feet or less above the adjacent existing roadway grade to ensure unobstructed lines of sight.

- To maximize the available sight line looking west from Pine Hill Road onto Parmenter Road the area within the sight line triangle should be regraded, the stone wall should be removed and reset to a maximum height of 2.5 feet above the adjacent roadway grade and approximately four (4) trees should be removed. With said improvements the sight line (ISD) looking to the west from Pine Hill Road onto Parmenter Road can be maximized to approximately 250 feet which correlates to a design speed of approximately 25 mph.

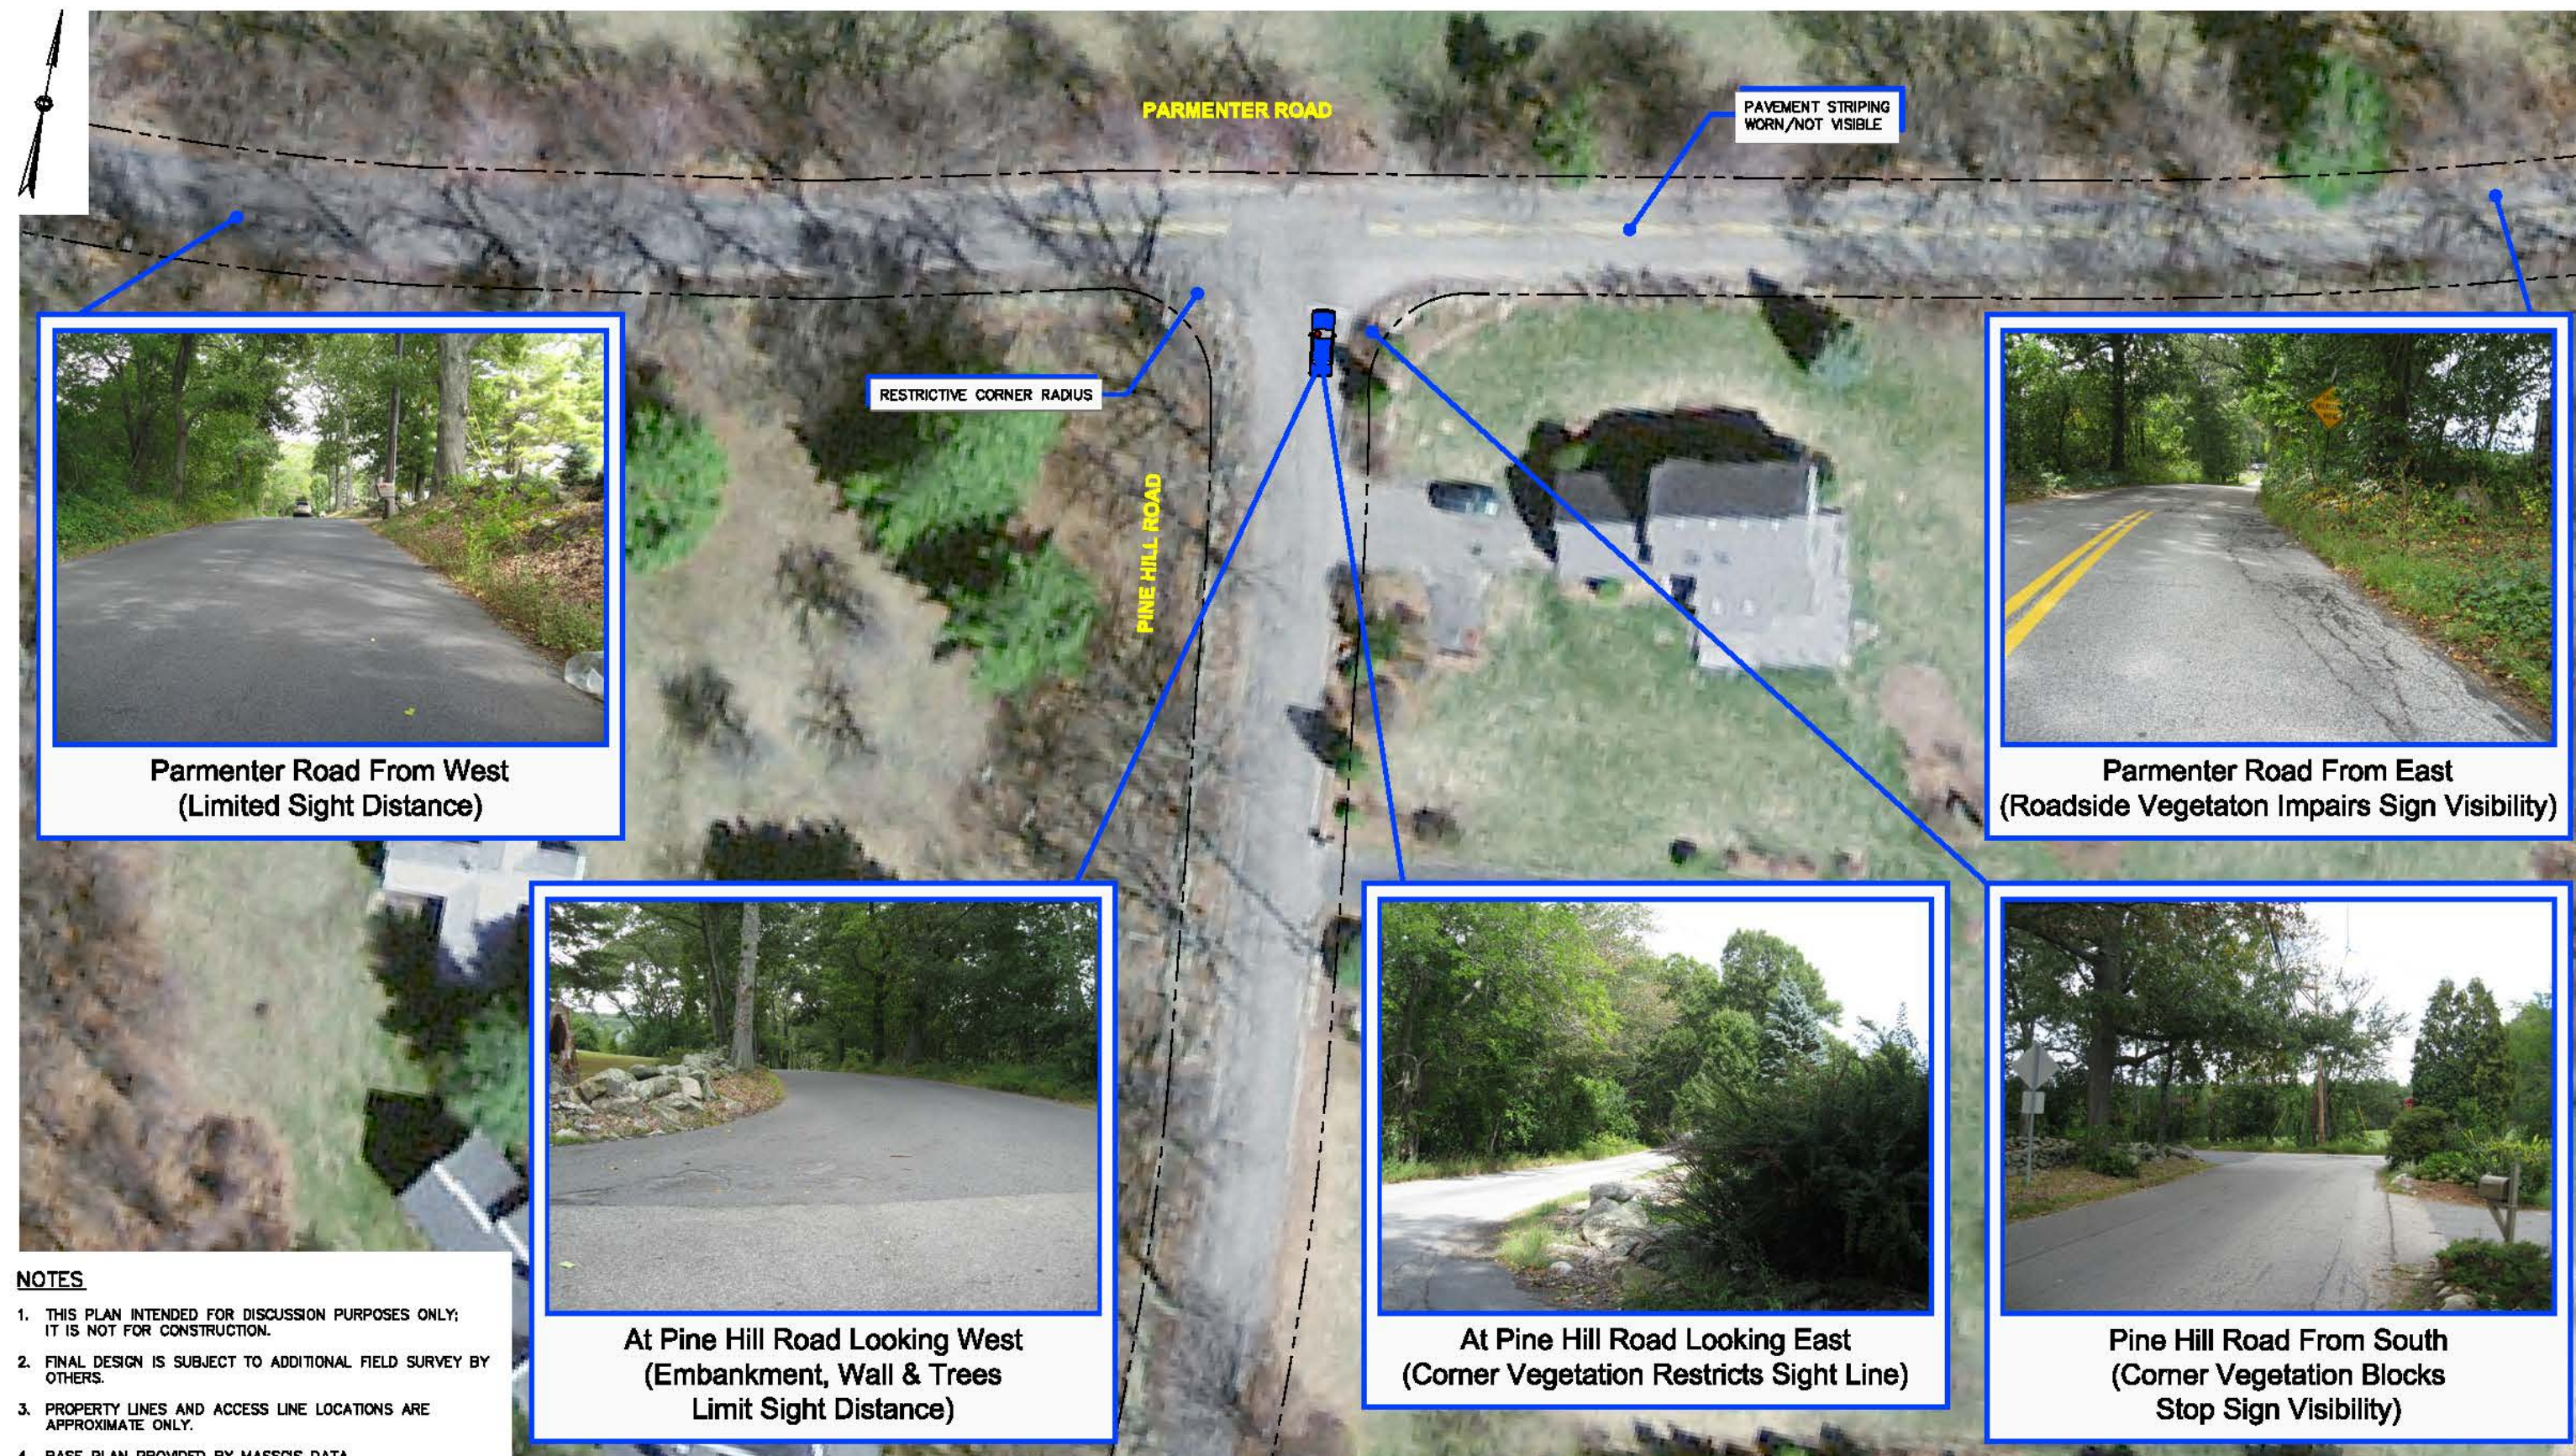
The safety and operations evaluation for the intersection of Parmenter Road and Pine Hill Road indicated the following traffic and safety issues as outlined in **Figure 5**:

- Parmenter Road is classified as rolling terrain with both vertical and horizontal curves with roadside obstructions in close proximity to the travel way including vegetation, trees and stone walls.

- While yellow centerlines and single white edge lines are provided in the adjacent communities no pavement markings within the Town of Southborough were evident at the time of this evaluation.

- Roadside vegetation along Parmenter Road impairs visibility to existing signage.
- Stopping sight distance (SSD) along Parmenter Road approaching Pine Hill Road from the west is limited to 250 feet by a vertical crest curve.

- The “STOP” sign on the Pine Hill northbound approach to Parmenter Road is blocked by vegetation. Said vegetation also impairs ISD looking to the east onto Parmenter Road from a STOP position further from the edge of travel way. A “STOP” line on the Pine Hill Road approach to Parmenter Road is also worn or no existent.

- The right turn corner radius from Parmenter Road to Pine Hill Road is restrictive.
